Sidewall Cord Impact Break (Bubble)

NEXEN TYRE

Vibration Causes Depending on Speed

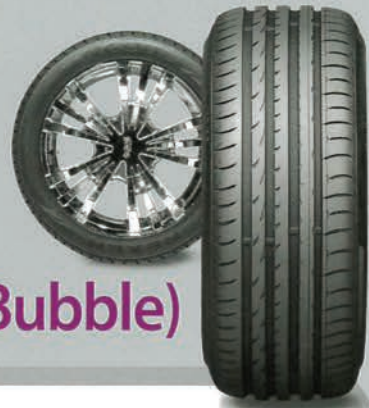
The carcass contains textile cord topping layers between steel belt and inner liner. If the textile cords of carcass are damaged due to sudden impact with a road hazard or a pothole, the sidewall of tire may arise like bump. This is why the internal air pressure pushes the surface through the gap in the cord. This is called Cord Impact Break(Bubble).

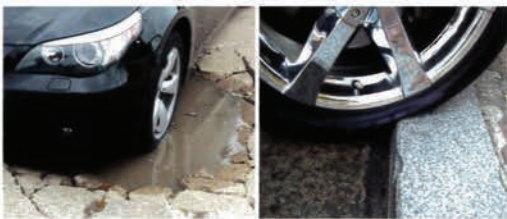
Possible Causes

Impact damage such as curb / pothole

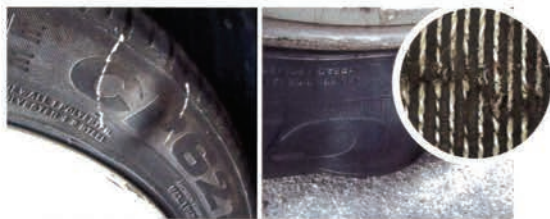
Result

Localized protrusion in the sidewall
