Sidewall Cord Impact Break (Bubble)

NEXEN TYRE

Vibration Causes Depending on Speed

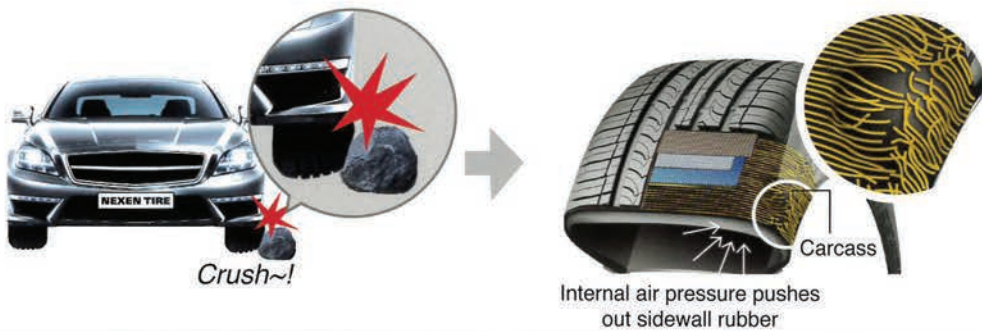
What is Cord Impact Break?

The carcass contains textile cord topping layers between steel belt and inner liner. If the textile cords of carcass are damaged due to sudden impact with a road hazard or a pothole, the sidewall of tire may arise like bump. This is why the internal air pressure pushes the surface through the gap in the cord. This is called Cord Impact Break(Bubble).

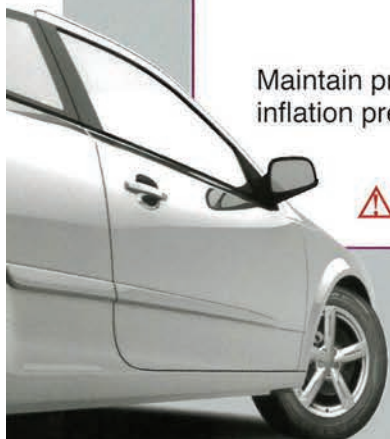
⚠ It is very dangerous to drive in the condition of cord impact break.

Avoid tread surface cuts and pothole impact if possible.

Drive on harsh bumpy road at low speed.

Maintain proper tire inflation pressure.

Check the tire for damage frequently.

Avoid contact with curbs.
